Fort Ord Reuse Authority Pilot Deconstruction Project

STAN COOK
PILOT DECONSTRUCTION PROJECT COORDINATOR

Final Report
December - 1997

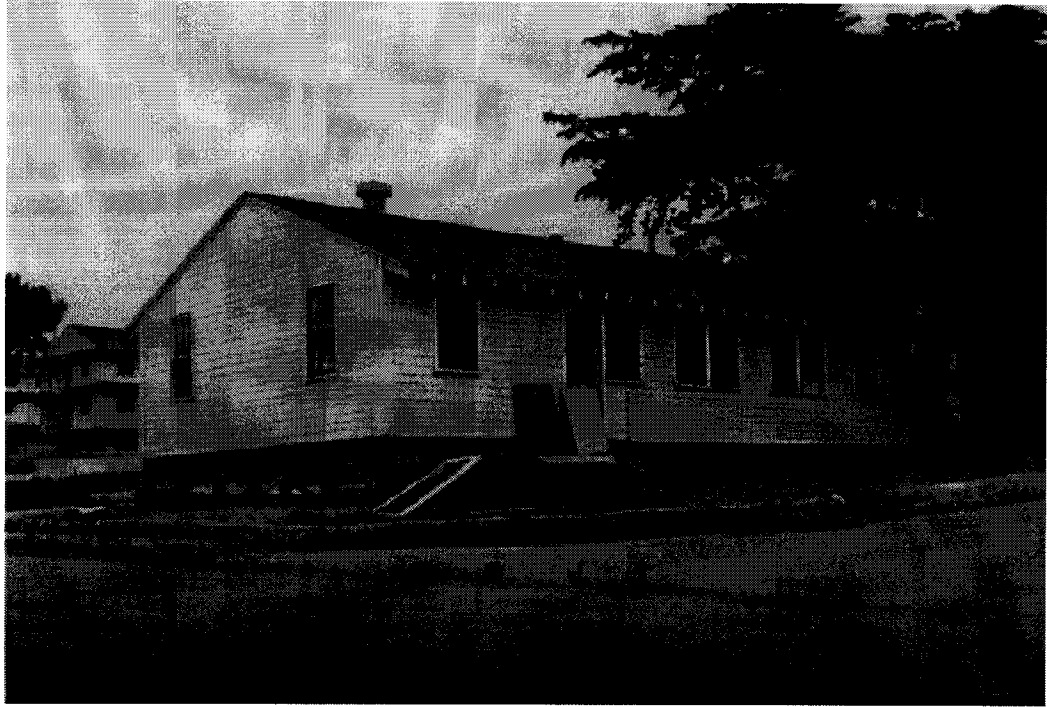
Photo - Buildings 1801, 1807, 2182 & 2184.

Building 1801 being prepared for relocation

Building 1807 was deconstructed.

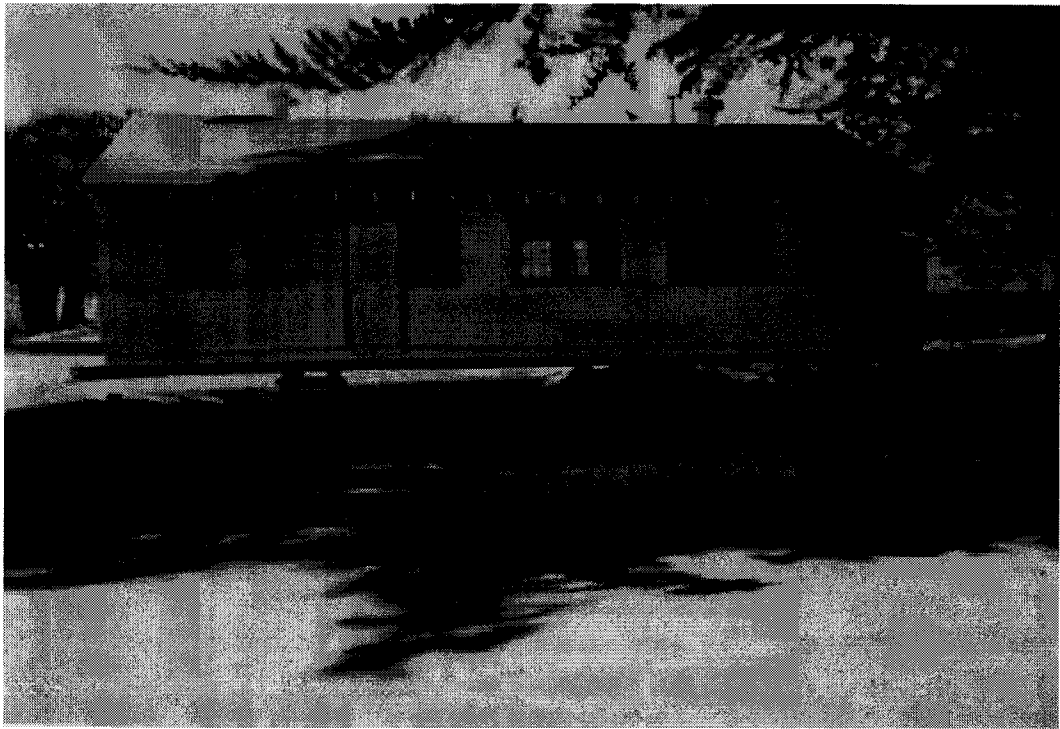
Building 1801 Ready for Move

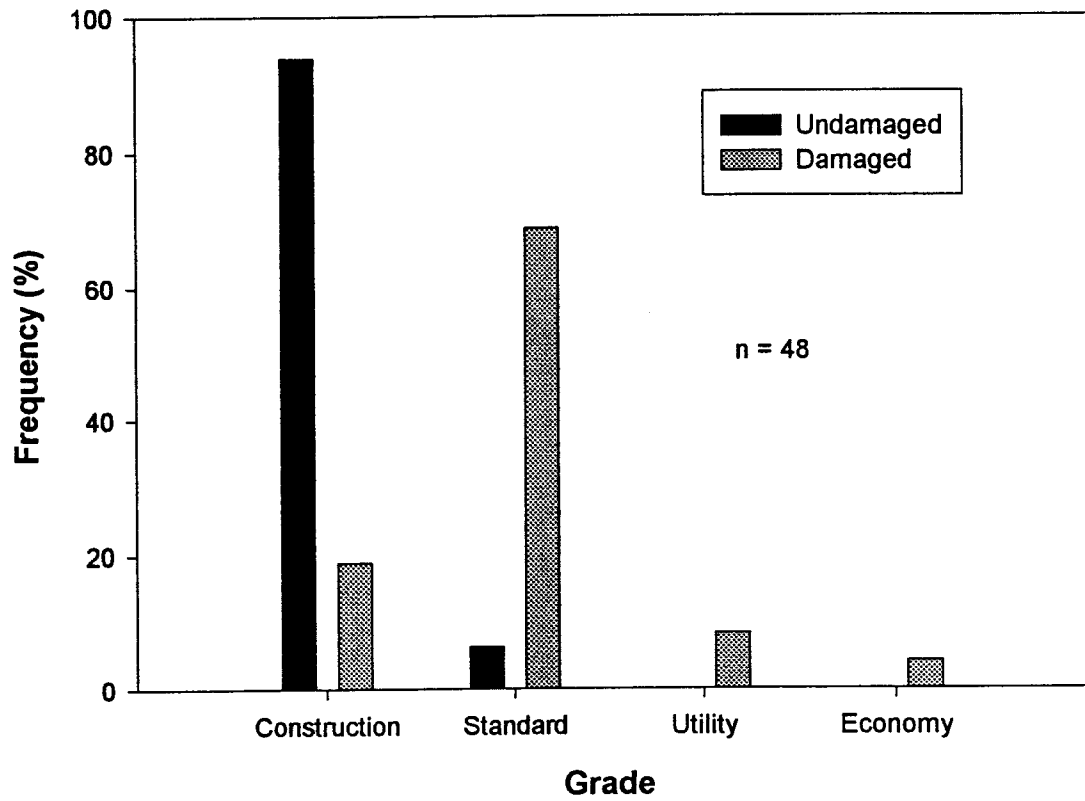
Figure 1

Grade Reduction Due to Damage
2x4 Lumber
(All Forms of Damage)

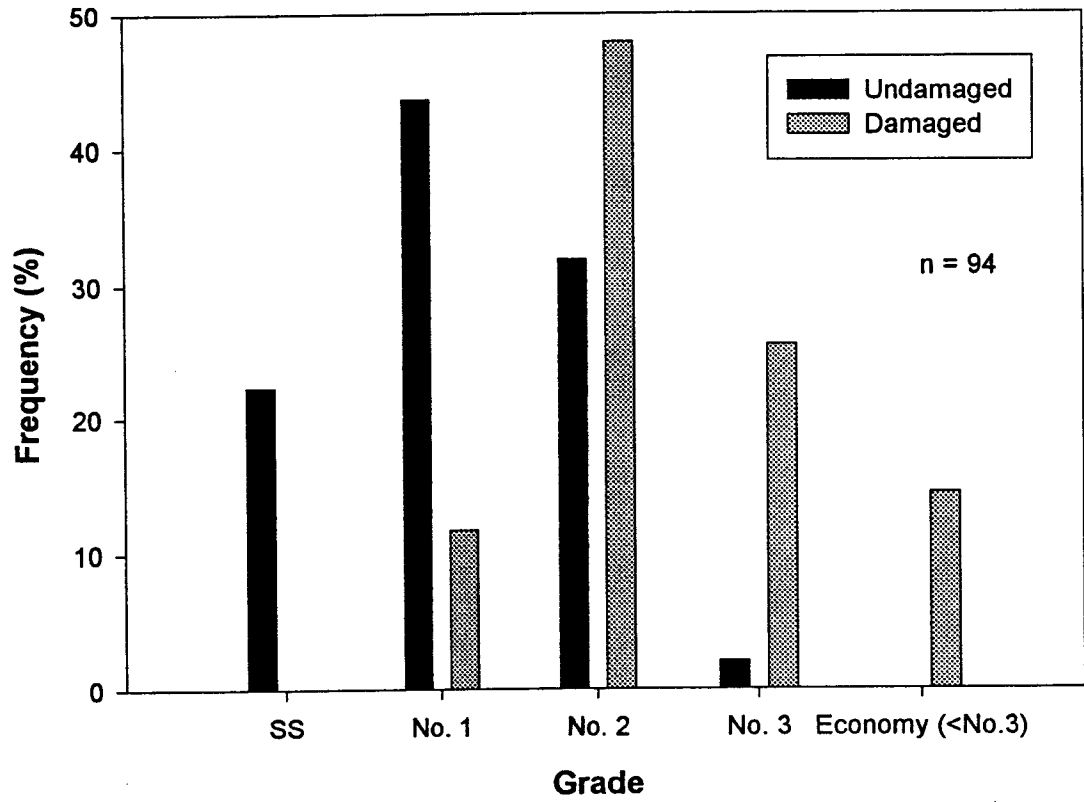
Figure 2

Grade Reduction Due to Damage
2x6 Lumber
(All Forms of Damage)

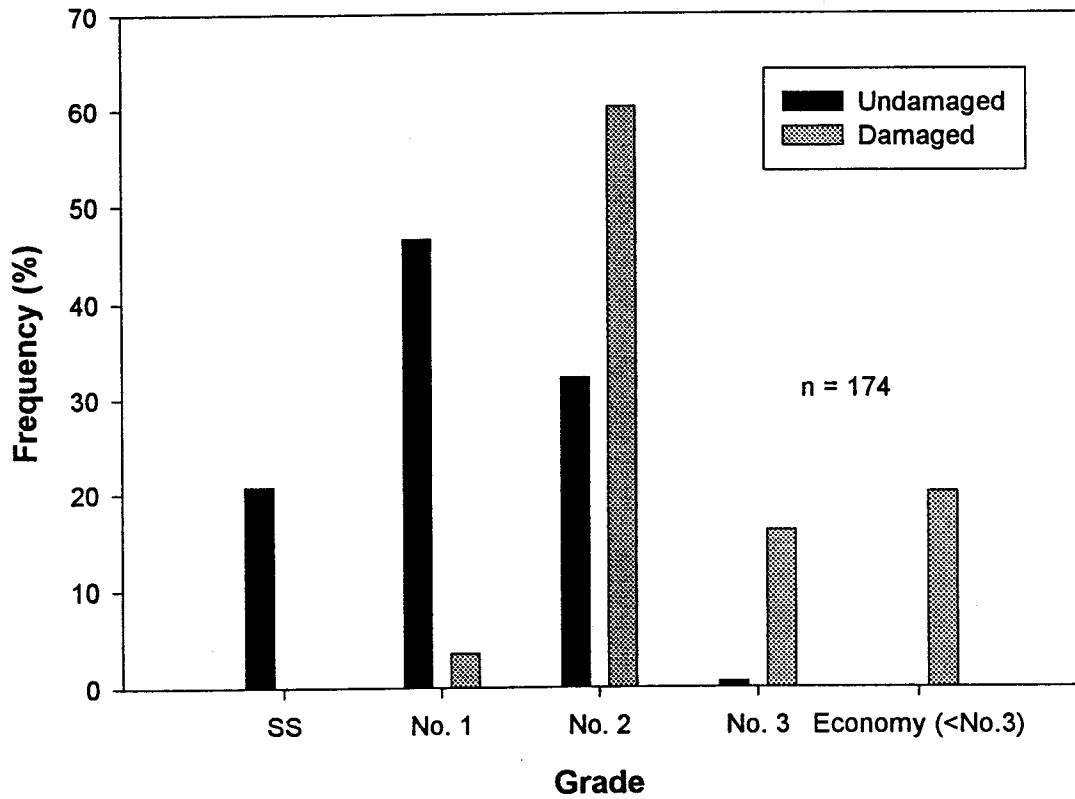
Figure 3

Grade Reduction Due to Damage
2x8 Lumber
(All Forms of Damage)

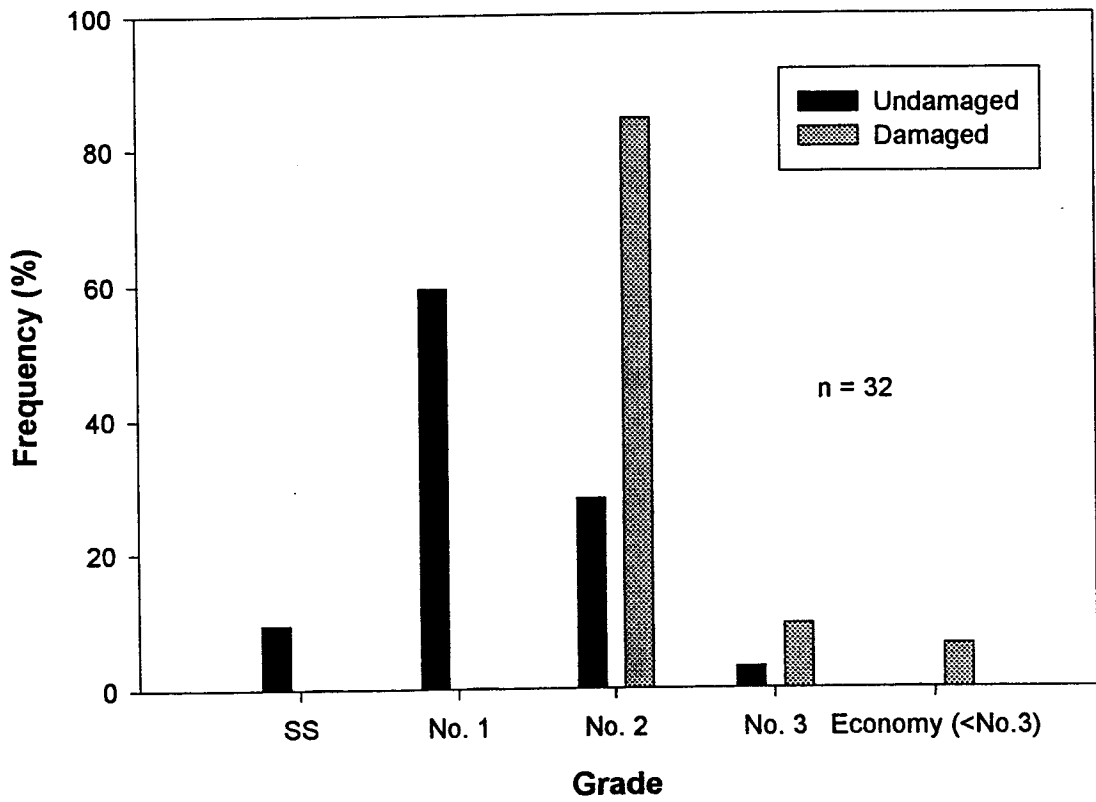
Figure 4
Grade Reduction Due to Damage
2x10 Lumber
(All Forms of Damage)

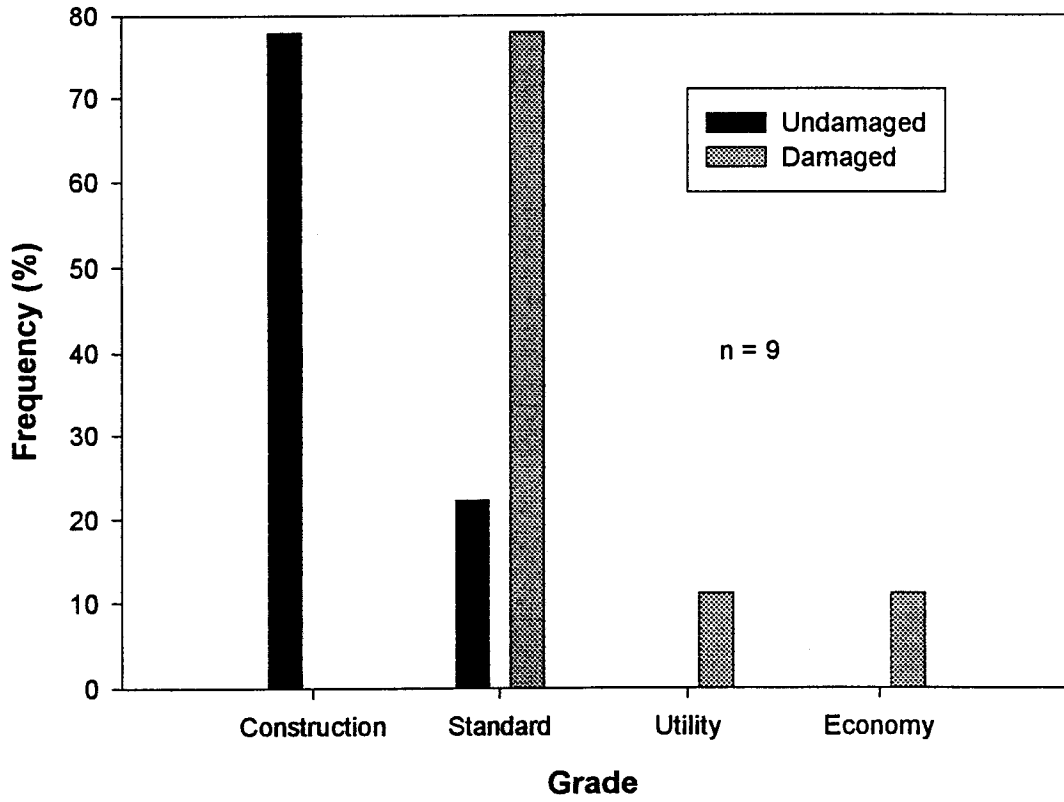
Figure 5

**Grade Reduction Due to Damage
2x4 Lumber
(Deconstruction Damage Only)**

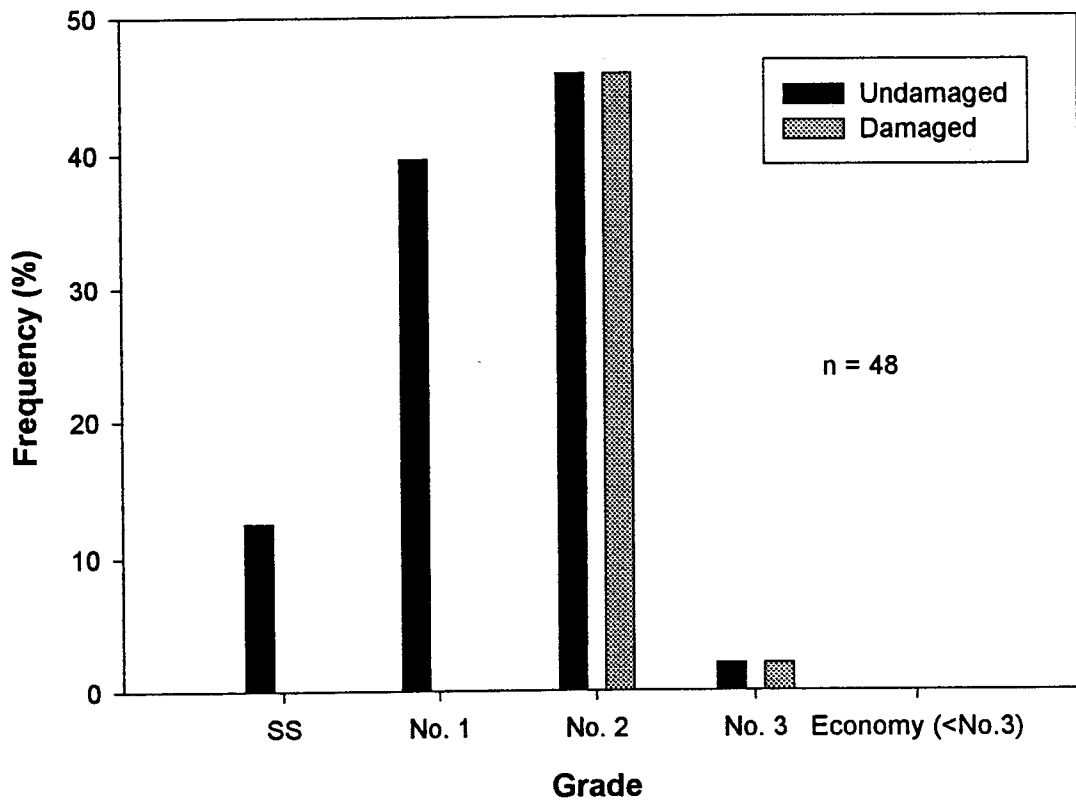
Figure 6

**Grade Reduction Due to Damage
2x6 Lumber
(Deconstruction Damage Only)**

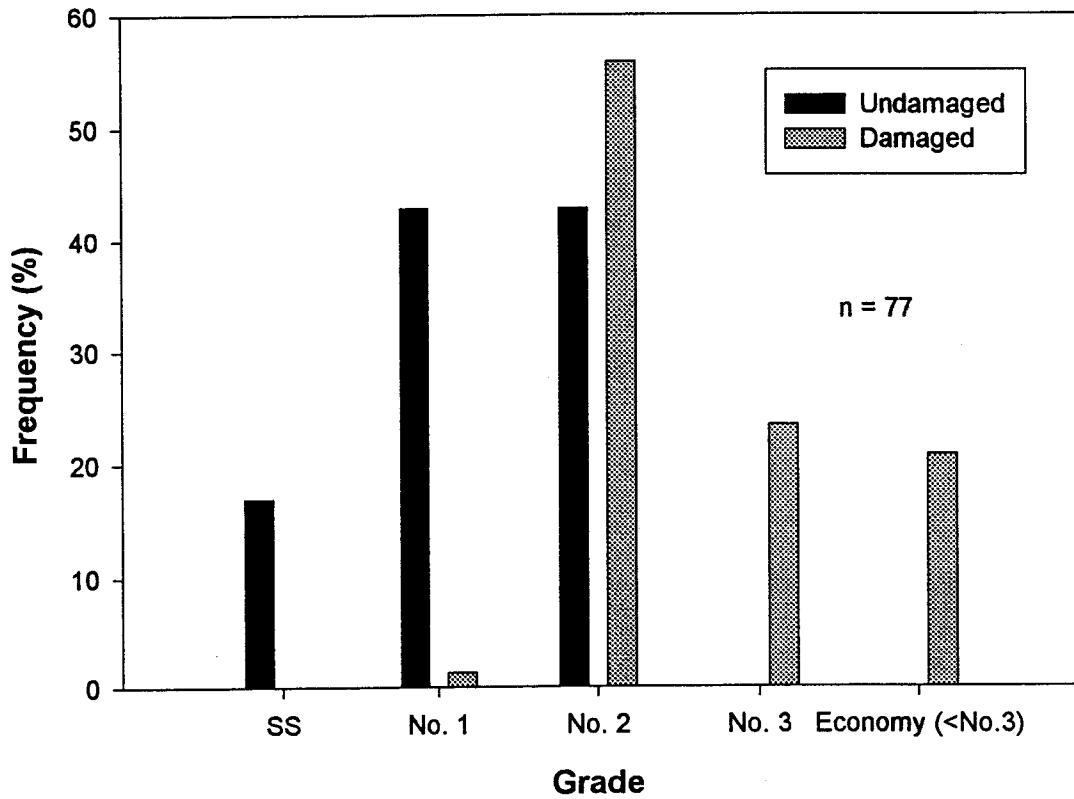
Figure 7

Grade Reduction Due to Damage
2x8 Lumber
(Deconstruction Damage Only)

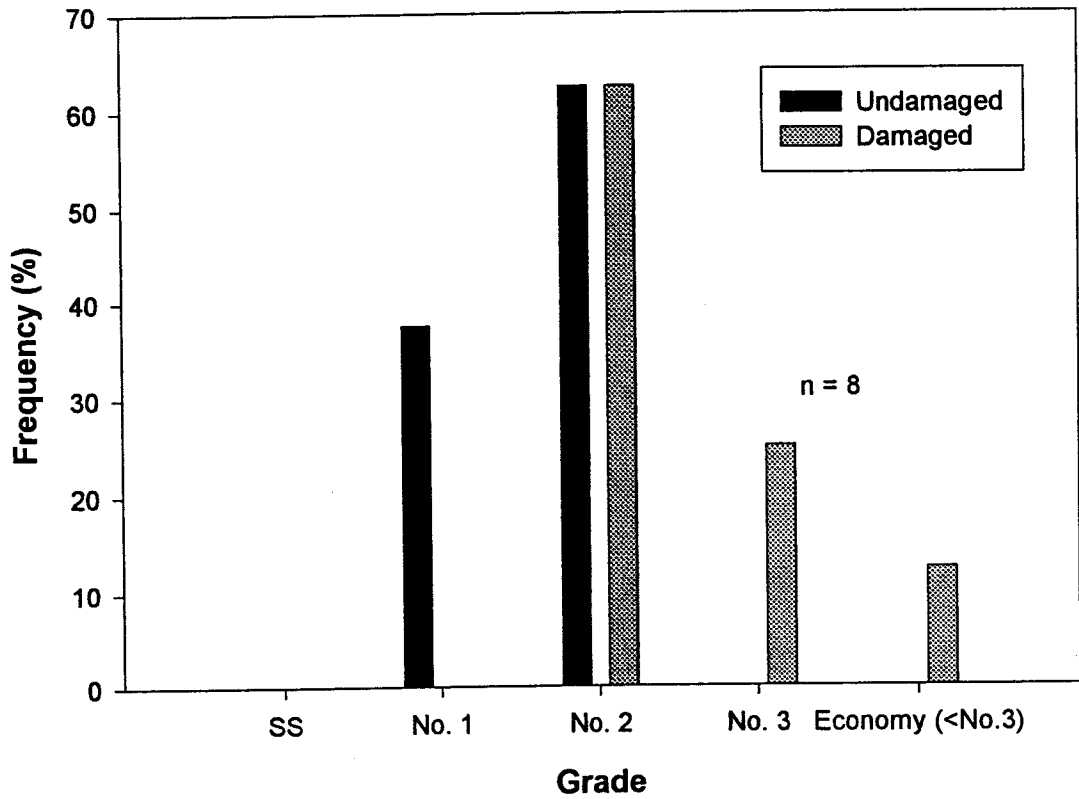
Figure 8

**Grade Reduction Due to Damage
2x10 Lumber
(Deconstruction Damage Only)**
