S201-40-410-04

Task 3- Pre-Demolition

Hazardous Materials Survey, 28

Buildings, Surplus II, Seaside, CA

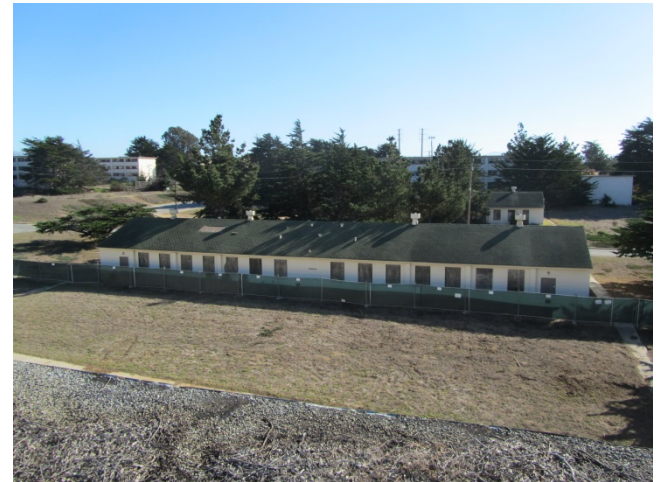
# Administration Buildings (AD)

Date of Construction: 1954

Interior Square Footage: 5,125 – 8,215

- 5 AD Buildings (3 small, 2 large)
- On North side of East parcel & North side of central parcel
- 1-story concrete masonry walls & foundation
- Used for training then Administration

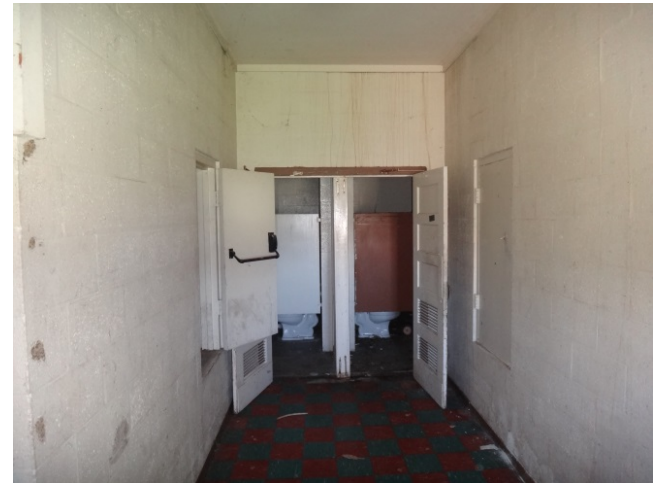
# Administration Buildings (AD)

- **Asbestos:**
  - Wallboard/Joint Compound, Skim Coat
  - Vinyl Floor Tile/Mastic
  - Fire Door Insulation
  - Cement pipes and Flex Joints
  - Misc. Putty, Mastics & Sealants
- **Lead:** lead based and containing paints found both interior and exterior of AD buildings, and lead containing ceramic tiles are present
- **Other Hazardous Materials:** Fluorescent tubes, batteries, PCB containing light ballasts, and ozone depleting chemicals
- **Waste Characterization:** Lead in building materials was identified at levels classifying it as Non-RCRA California Class I Hazardous Waste

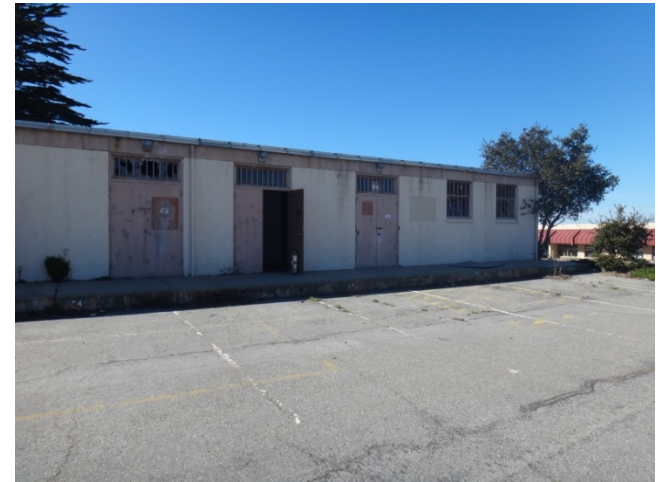
# Armory Buildings (AR)

Date of Construction: 1970

Interior Square Footage: 12,194

- 2 AR buildings
- Located on Northeast & Northwest sides of central parcel
- 1-story concrete masonry walls & foundation
- Mechanical room with boiler & hot water heater

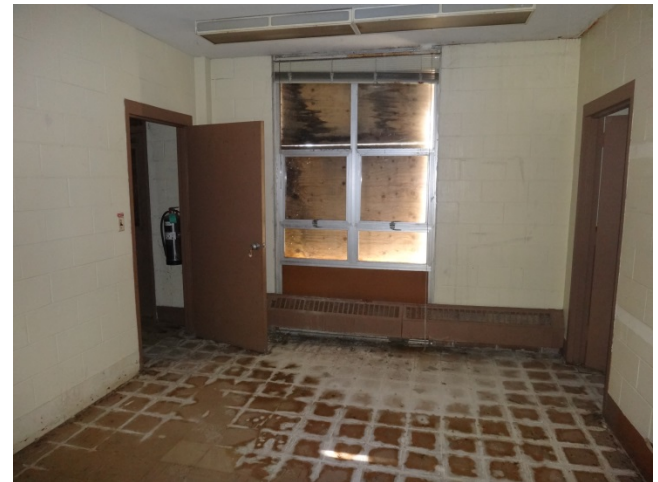
# Armory Buildings (AR)

- **Asbestos:**
  - Wallboard/Joint Compound
  - Vinyl Floor Tile/Mastic
  - Heat Shields on Lights
  - Cement Panels and Piping
  - Misc. Putty, Mastics , Sealants, & Glazing
- **Lead:** lead based and containing paints found both interior and exterior
- **Other Hazardous Materials:** Fluorescent tubes and other non-incandescent lamps, PCB containing light ballasts, electronic waste, and ozone depleting chemicals
- **Waste Characterization:** Lead in building materials was identified at levels classifying it as Non-RCRA California Class I Hazardous Waste

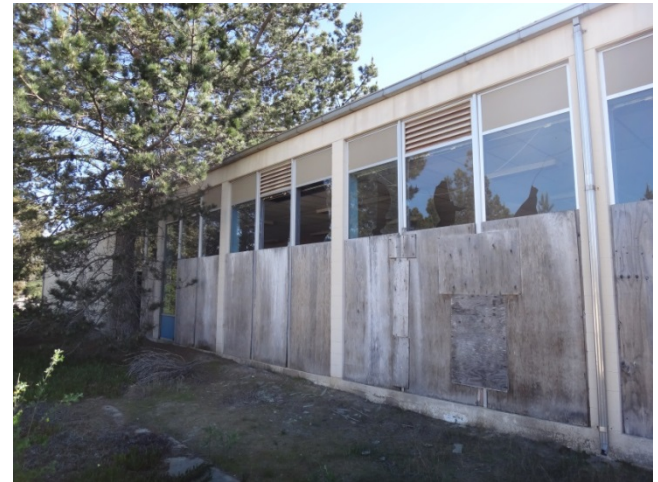
# Cafeteria Building (CF)

Date of Construction: 1970

Interior Square Footage: 12,194

- Located on Southeast side of central parcel
- 1-story concrete masonry walls & foundation
- Mechanical room with boiler & tanks

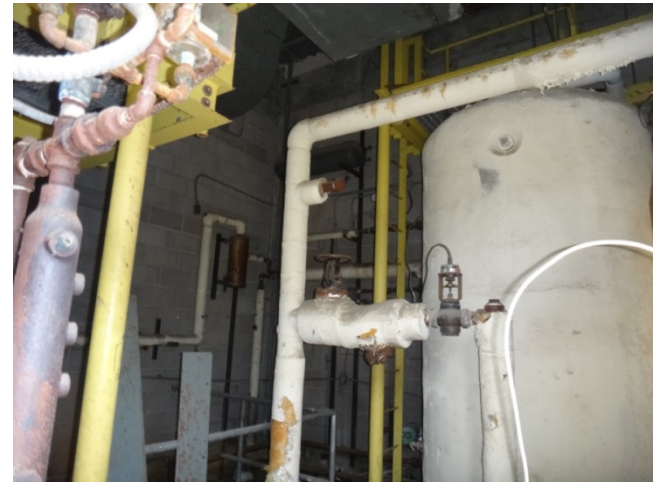
# Cafeteria Building (CF)

- **Asbestos:**
  - Vinyl Floor Tile/Mastic
  - Heat Shields on Lights
  - Insulation, Insulator, Packing
  - Cement Panels & Piping
  - Insulator Paper
  - Misc. Mastics , Sealants, Gasket
- **Lead:** lead based and containing paints found both interior and exterior
- **Other Hazardous Materials:** Fluorescent tubes and other non-incandescent lamps, thermostat triggers, PCB containing light ballasts, ozone depleting chemicals, and halon in fire suppression system
- **Waste Characterization:** Lead in building materials was identified at levels classifying it as Non-RCRA California Class I Hazardous Waste

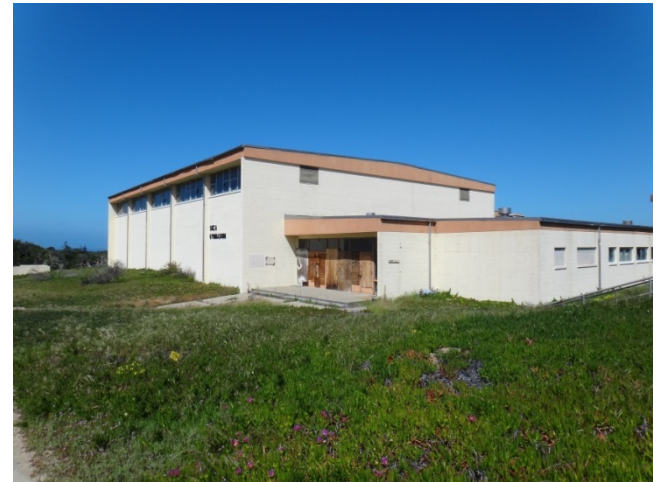
# Gymnasium Building (G)

Date of Construction: 1970

Interior Square Footage: 20,457

- Located on North side of west parcel
- 1-story concrete masonry walls & foundation
- Mechanical room with boiler & tanks
- Adjacent to Gymnasium is a metal shed (GA)

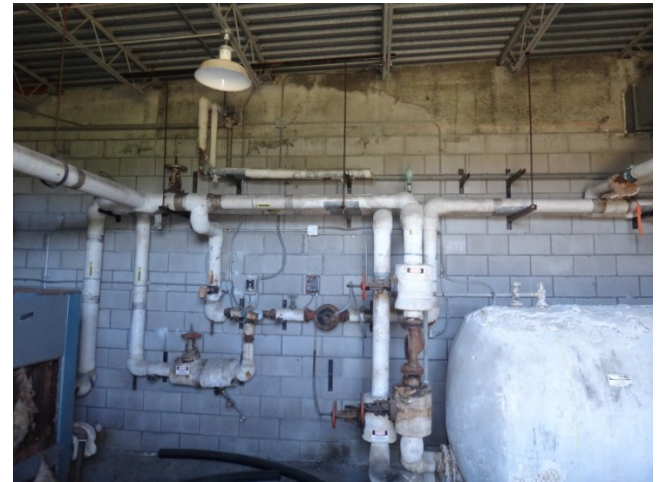
# Gymnasium Building (G)

- **Asbestos:**
  - Vinyl Floor Tile/Mastic
  - Wallboard/Joint Compound
  - Thermal System Insulation
  - Insulation, Packing, Jacketing
  - Cement Piping
  - Misc. Mastics , Gasket , Glazing, Putty
- **Lead:** lead based and containing paints found both interior and exterior
- **Other Hazardous Materials:** Fluorescent tubes and other non-incandescent lamps, electronic waste, PCB containing light ballasts, ozone depleting chemicals, and petroleum products in air compressors
- **Waste Characterization:** Lead in building materials was identified at levels classifying it as Non-RCRA California Class I Hazardous Waste

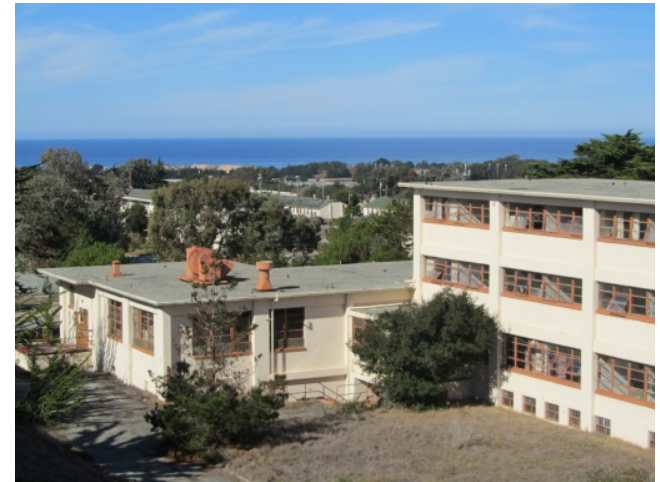
# Hammerhead Buildings (HH)

Date of Construction: 1954

Interior Square Footage: 40,653 – 42,017

- 8 HH Buildings
- Located on East parcel
- Reinforced concrete & concrete masonry walls
- Renovated in 1970's
- Handles are 3-story barracks renovated to dorm style
- Head area is kitchen/dining or offices
- Basement mechanical room with hot water tank in Head
- 2 south most HHs have 3 boilers in basement mechanical room

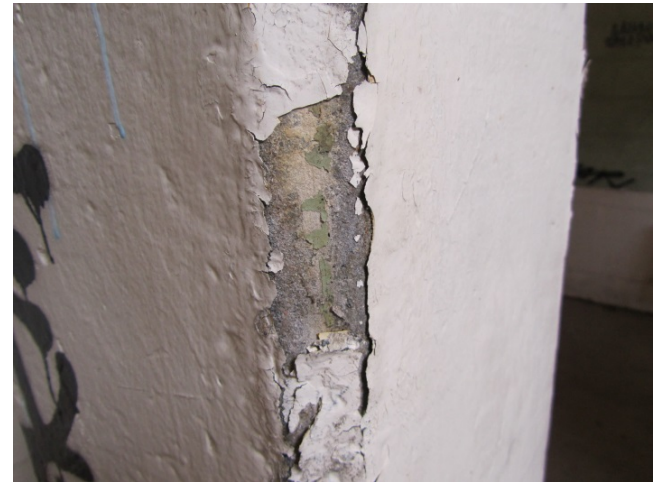
# Hammerhead Buildings (HH)

- **Asbestos:**
  - Skim Coat on Concrete
  - Vinyl Floor Tile/Mastic
  - Wallboard/Joint Compound
  - Thermal System Insulation
  - Cement Panels
  - Fire Door Insulation
  - Misc. Putty, Mastics , Sealants, Glazing & Gaskets
- **Lead:** lead based and containing paints found both interior and exterior and lead containing ceramic tiles are present
- **Other Hazardous Materials:** Fluorescent tubes and other non-incandescent lamps, batteries, PCB containing light ballasts and transformers, ozone depleting chemicals, low level radiation in smoke detectors and halon in fire suppression system
- **Waste Characterization:** Lead in building materials was identified at levels classifying it as RCRA Federal Class I Hazardous Waste

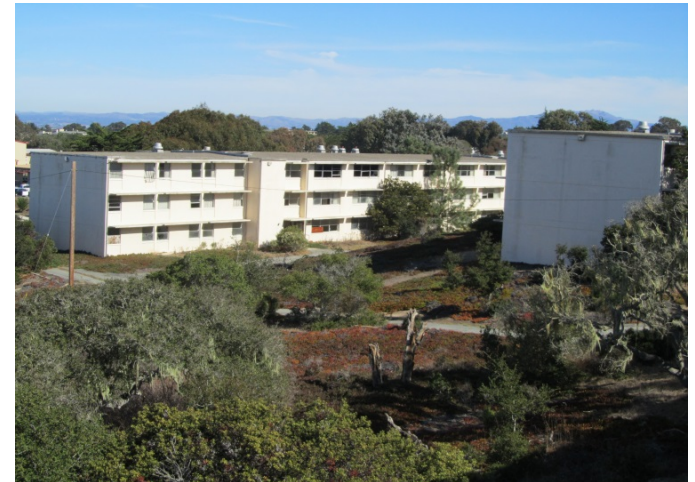
# Rolling Pin Buildings (RP)

Date of Construction: 1970

Interior Square Footage: 40,587

- 8 RP Buildings
- Located on West and central parcels
- Reinforced concrete & concrete masonry walls
- 3-story dorm style barracks
- Basement mechanical room boilers and tanks

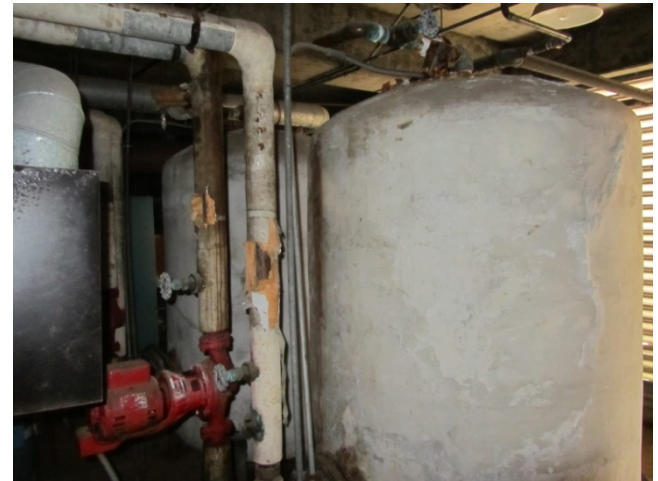
# Rolling Pin Buildings (RP)

- **Asbestos:**
  - Vinyl Floor Tile/Mastic
  - Heat Shields on Lights
  - Insulation, Insulators, Jacketing
  - Cement Piping
  - Vapor Barrier
  - Misc. Mastics , Sealants, Glazing
- **Lead:** lead based and containing paints found both interior and exterior and lead containing ceramic tiles are present
- **Other Hazardous Materials:** Fluorescent tubes and other non-incandescent lamps, batteries, PCB containing light ballasts, ozone depleting chemicals, and low level radiation in smoke detectors
- **Waste Characterization:** Lead in building materials was identified at levels classifying it as RCRA Federal Class I Hazardous Waste
